# IWT-5000
# Impulse Winding Tester

## LCD Inverter Module Testing

# 2. Root Cause Analysis

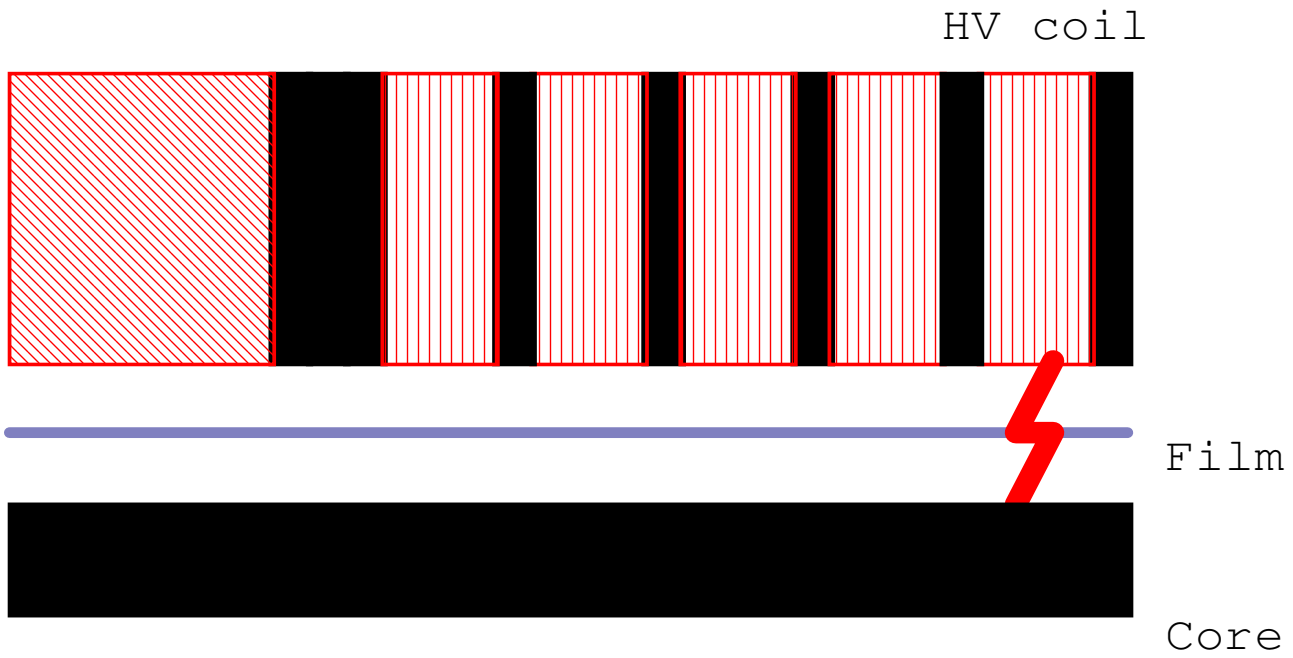
# 2.1 Root Cause Analyisis --Transformer

There is no enough space between HV coil and core

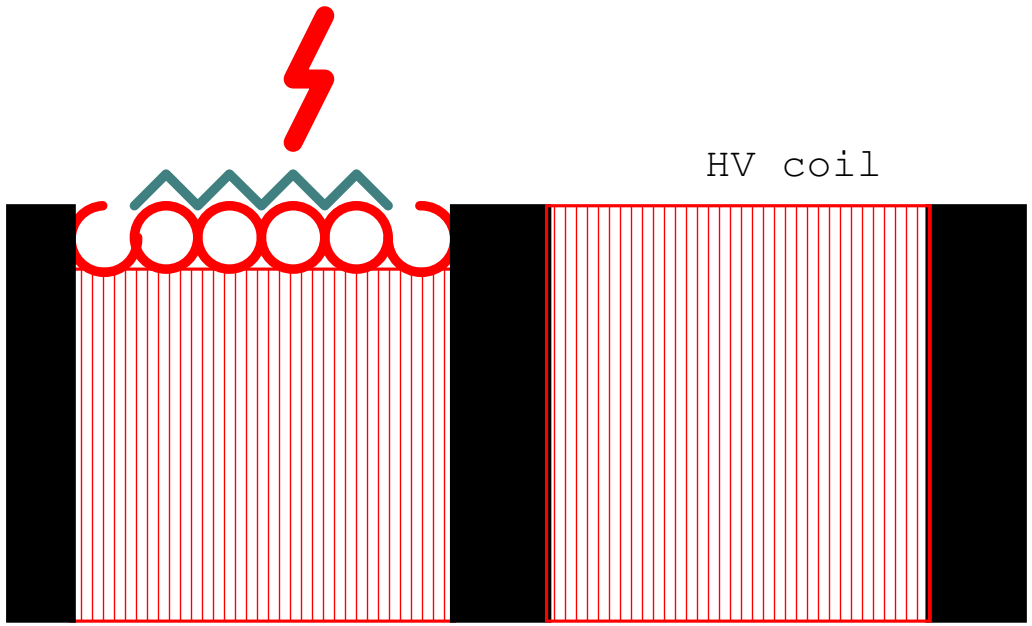
# 2.1 Root Cause Analysis --Transformer

The coil is discharging because of JACK damage or moisture

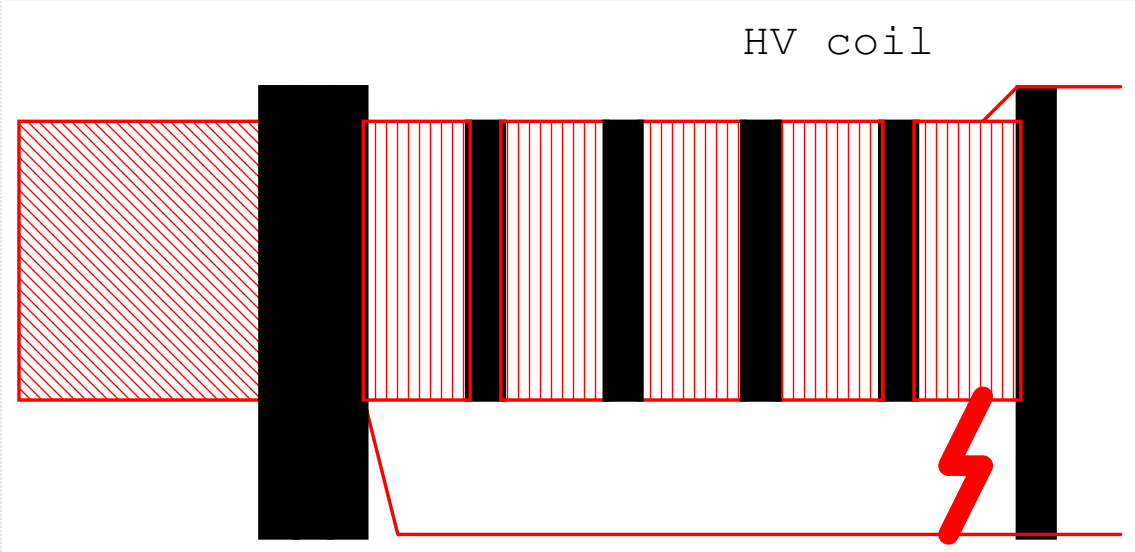
# 2.1 Root Cause Analysis --Transformer

The HV coil jack damage or bad withstand voltage.

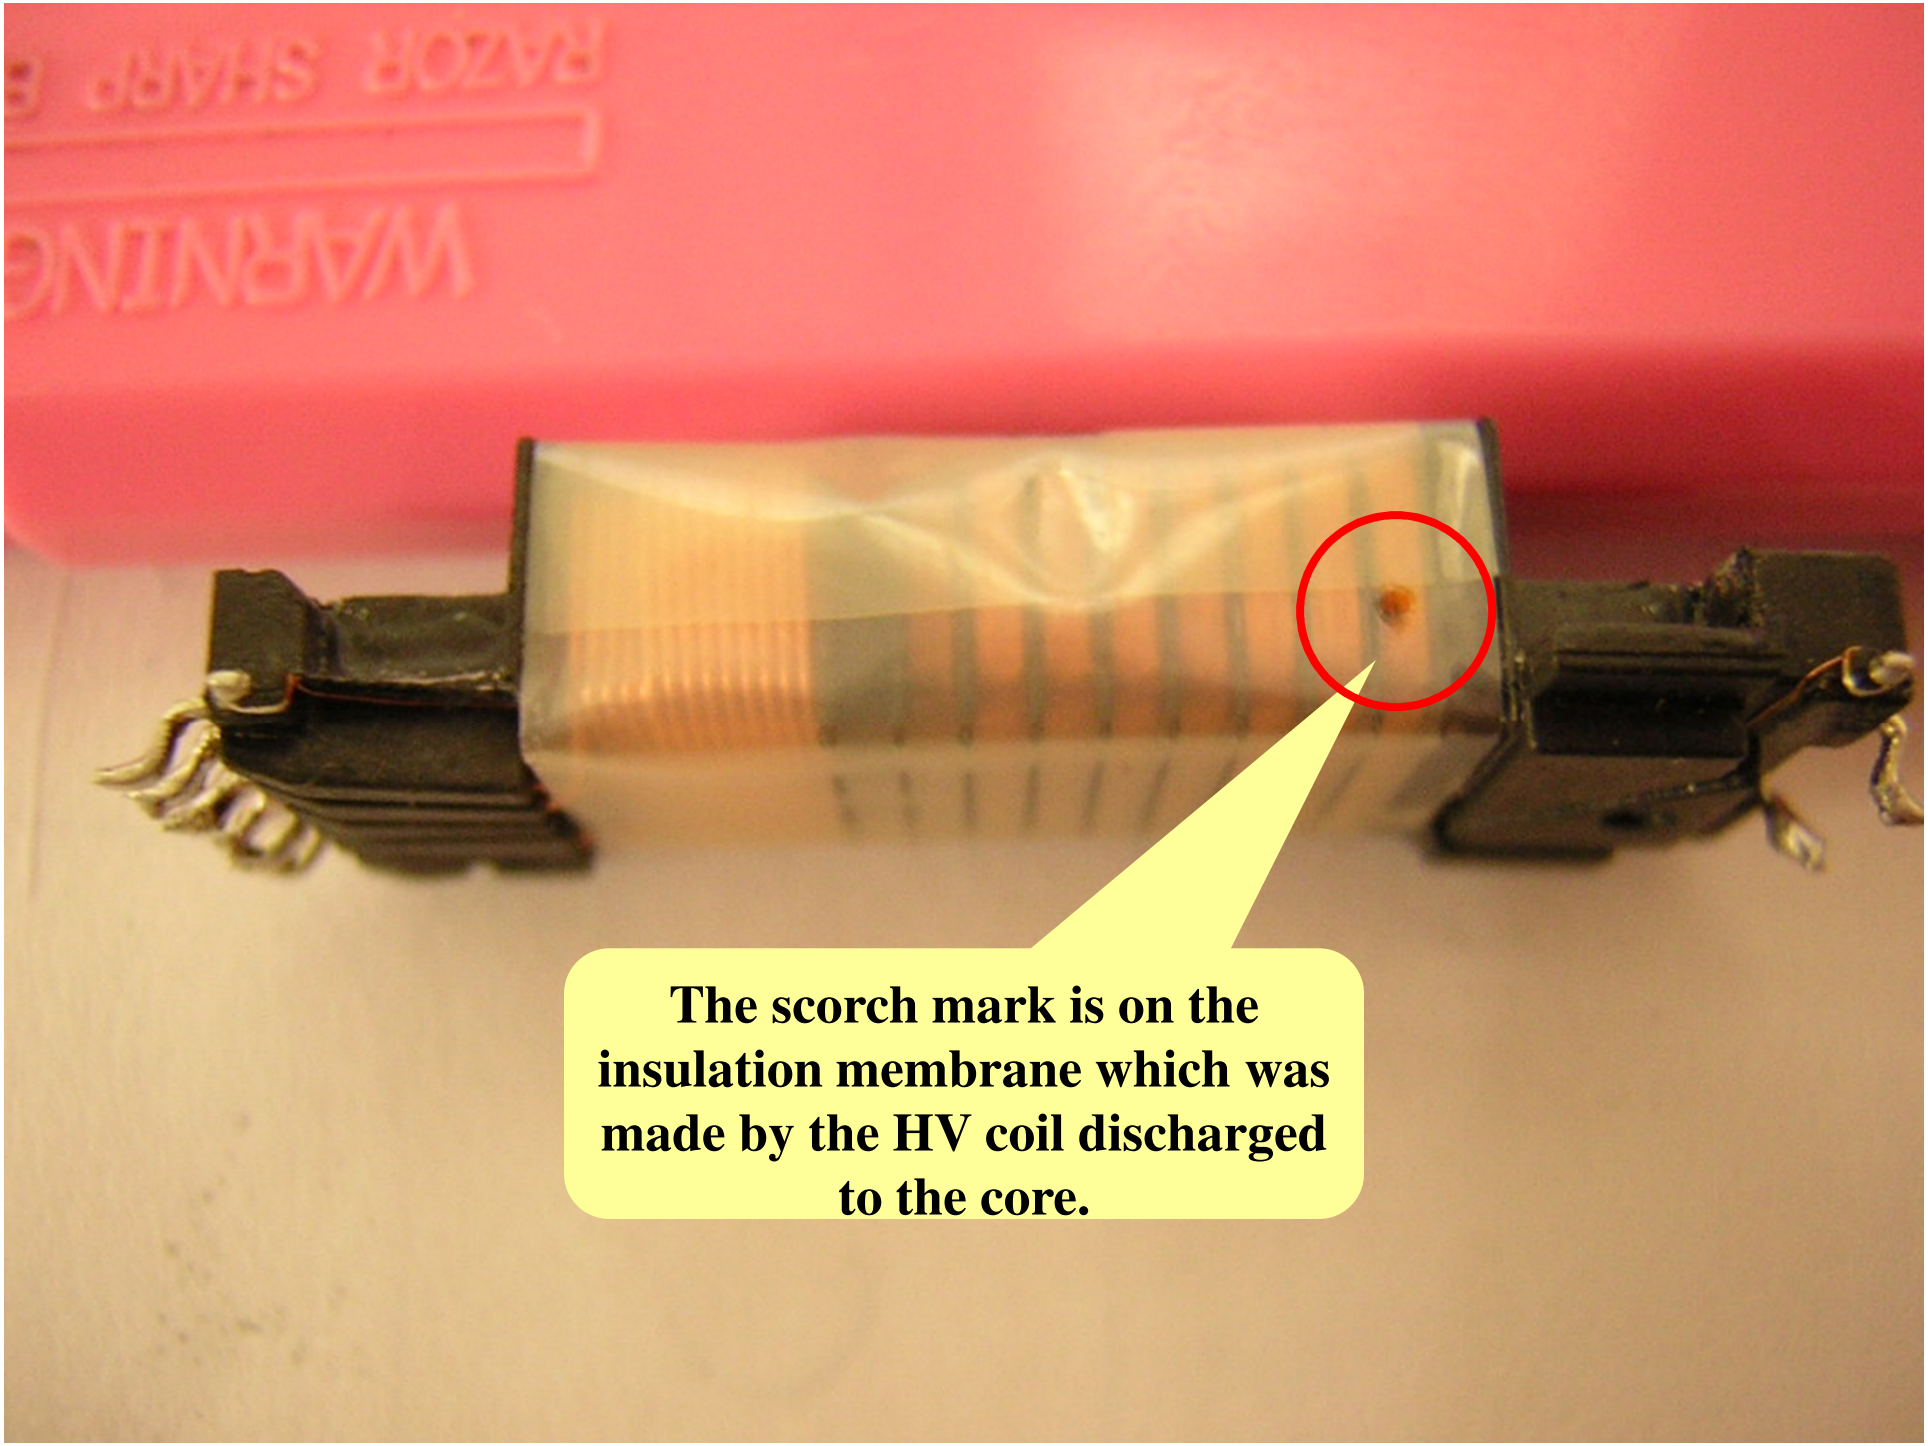
The scorch mark is on the insulation membrane which was made by the HV coil discharged to the core.

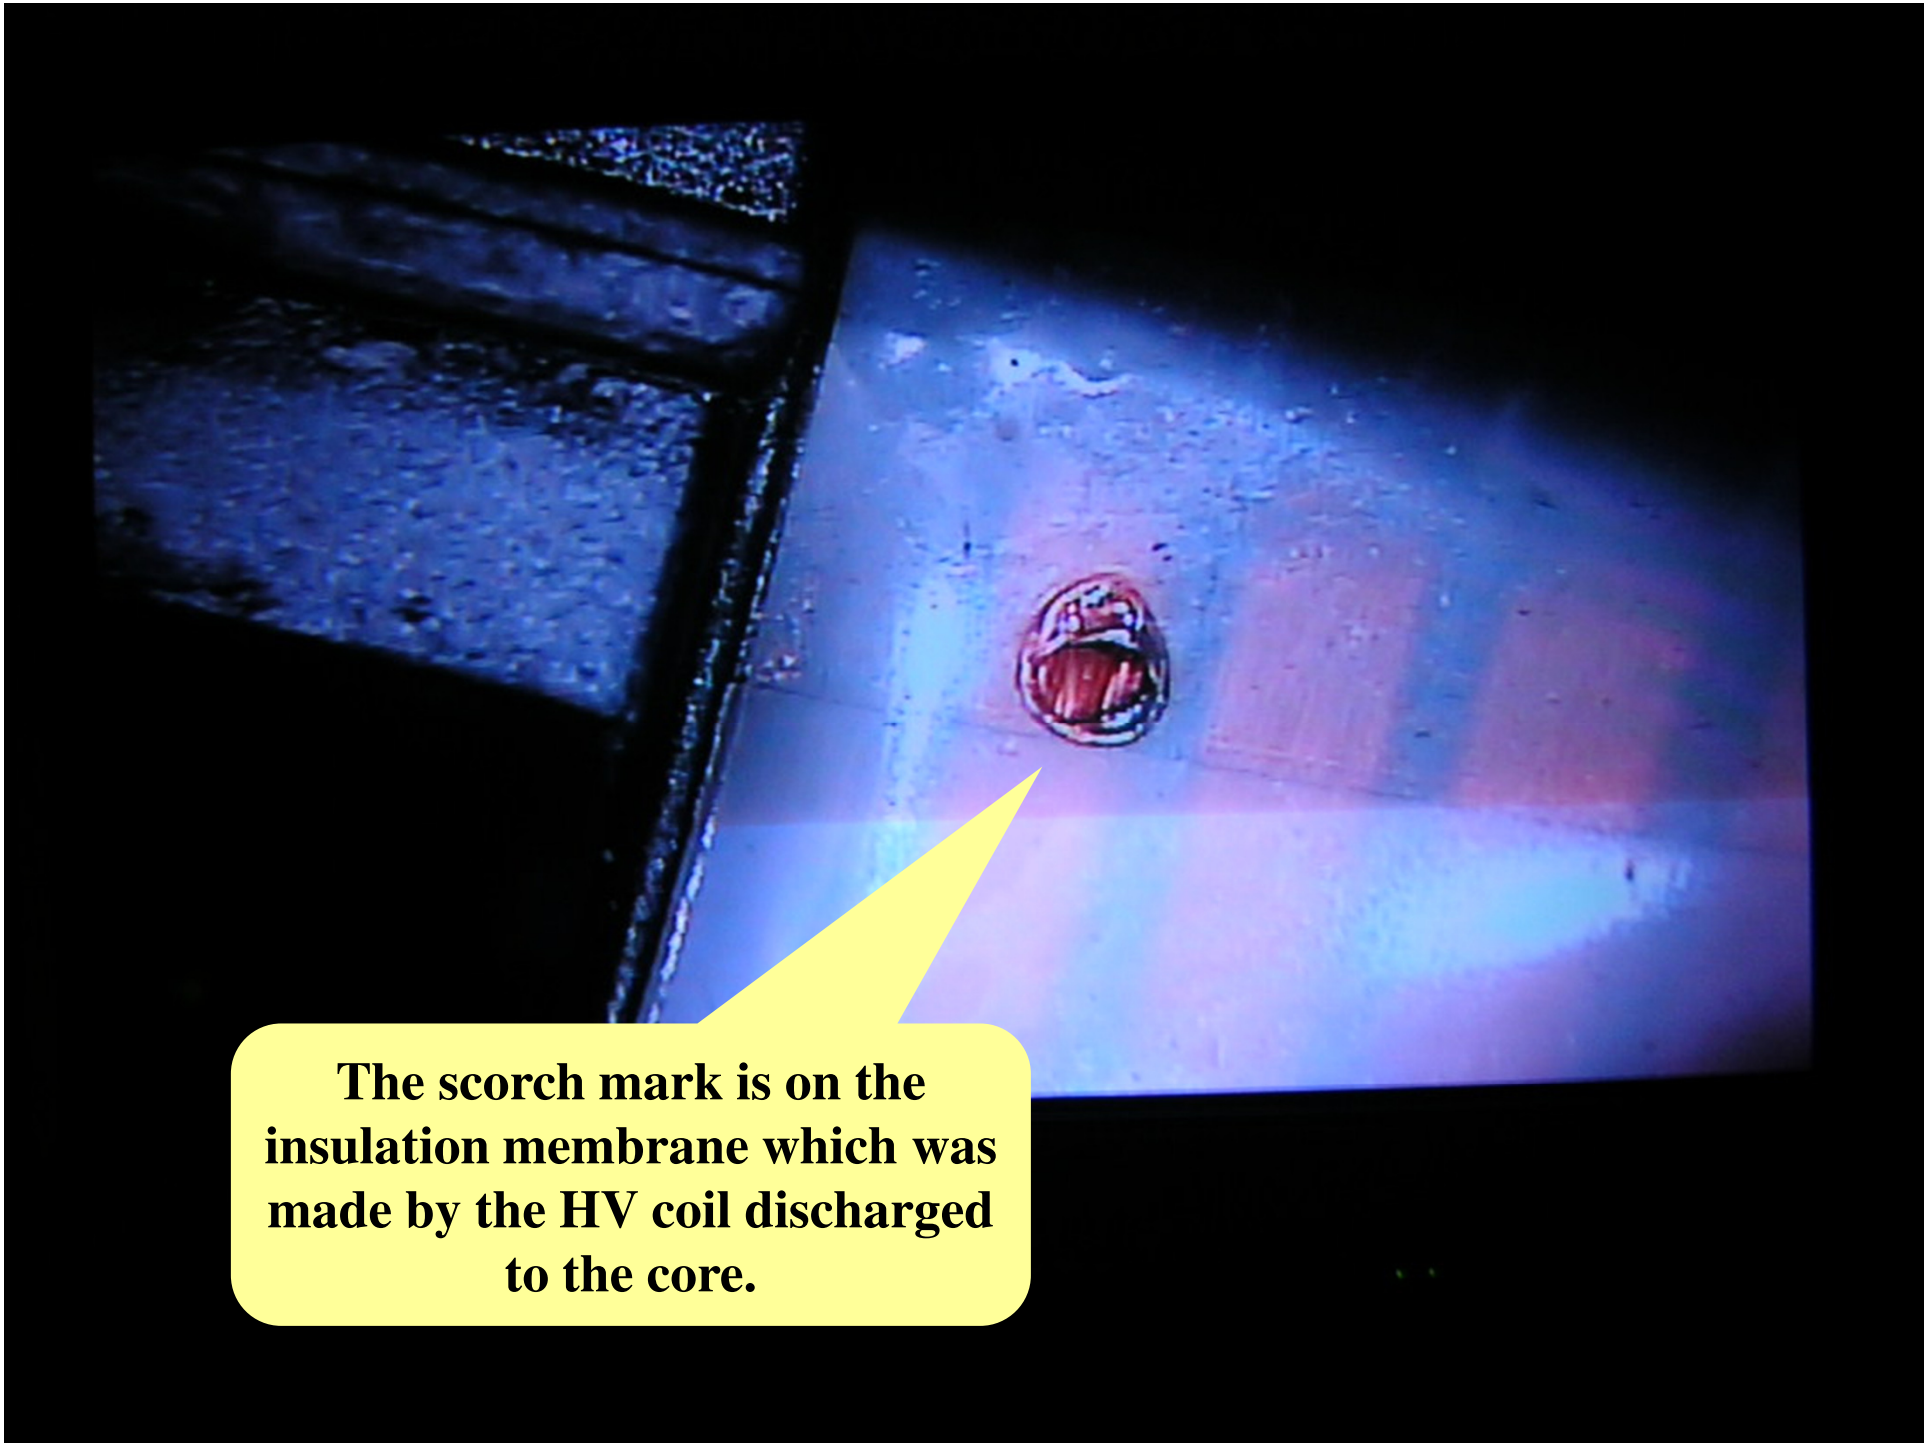
The scorch mark is on the insulation membrane which was made by the HV coil discharged to the core.

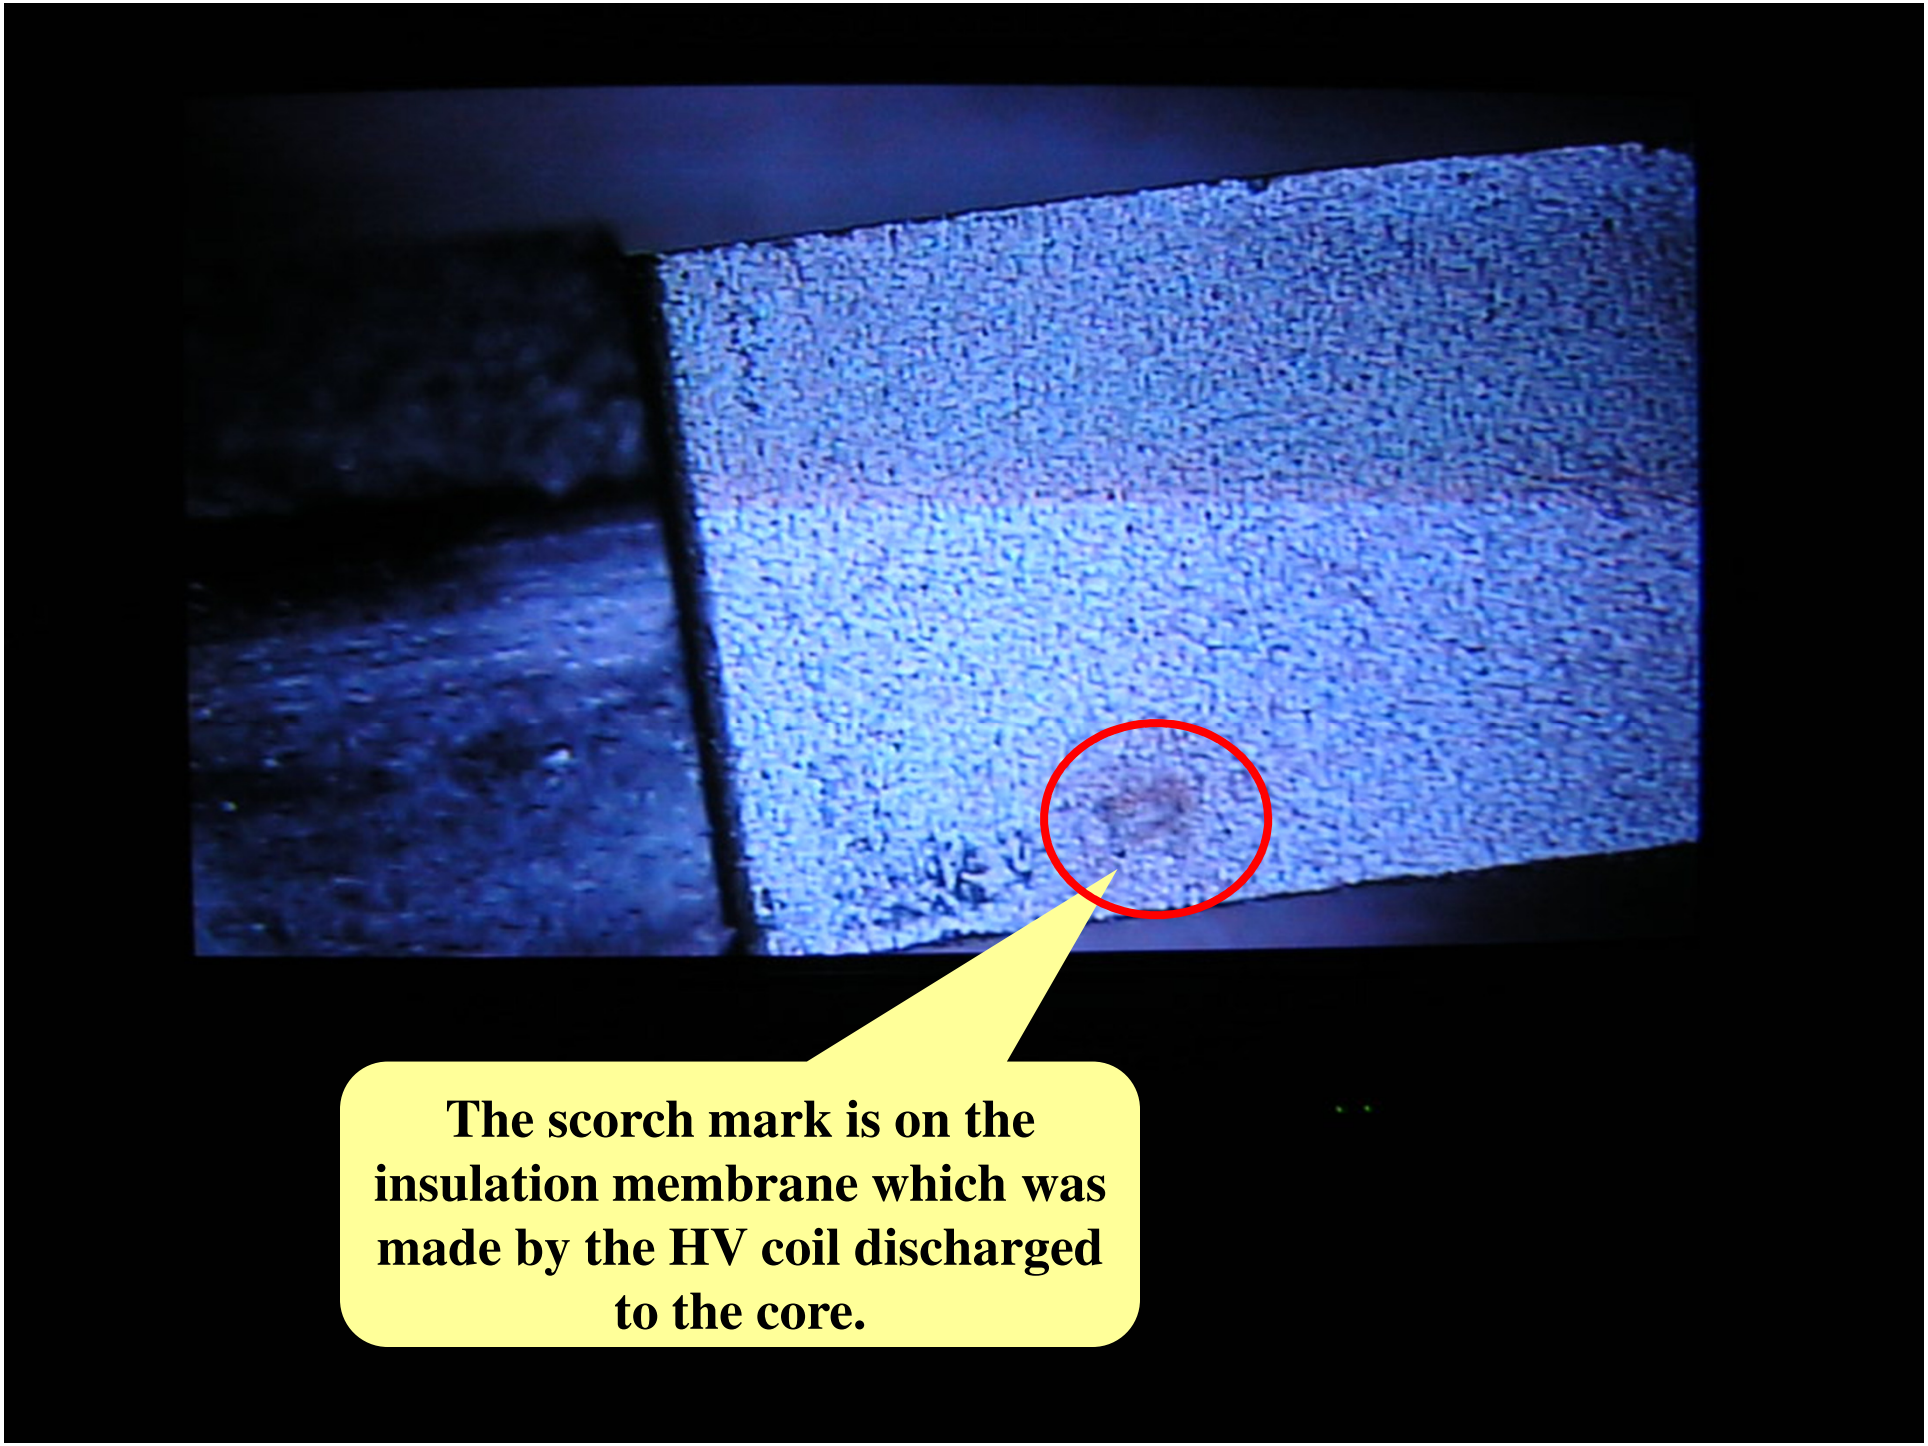
The scorch mark is on the insulation membrane which was made by the HV coil discharged to the core.

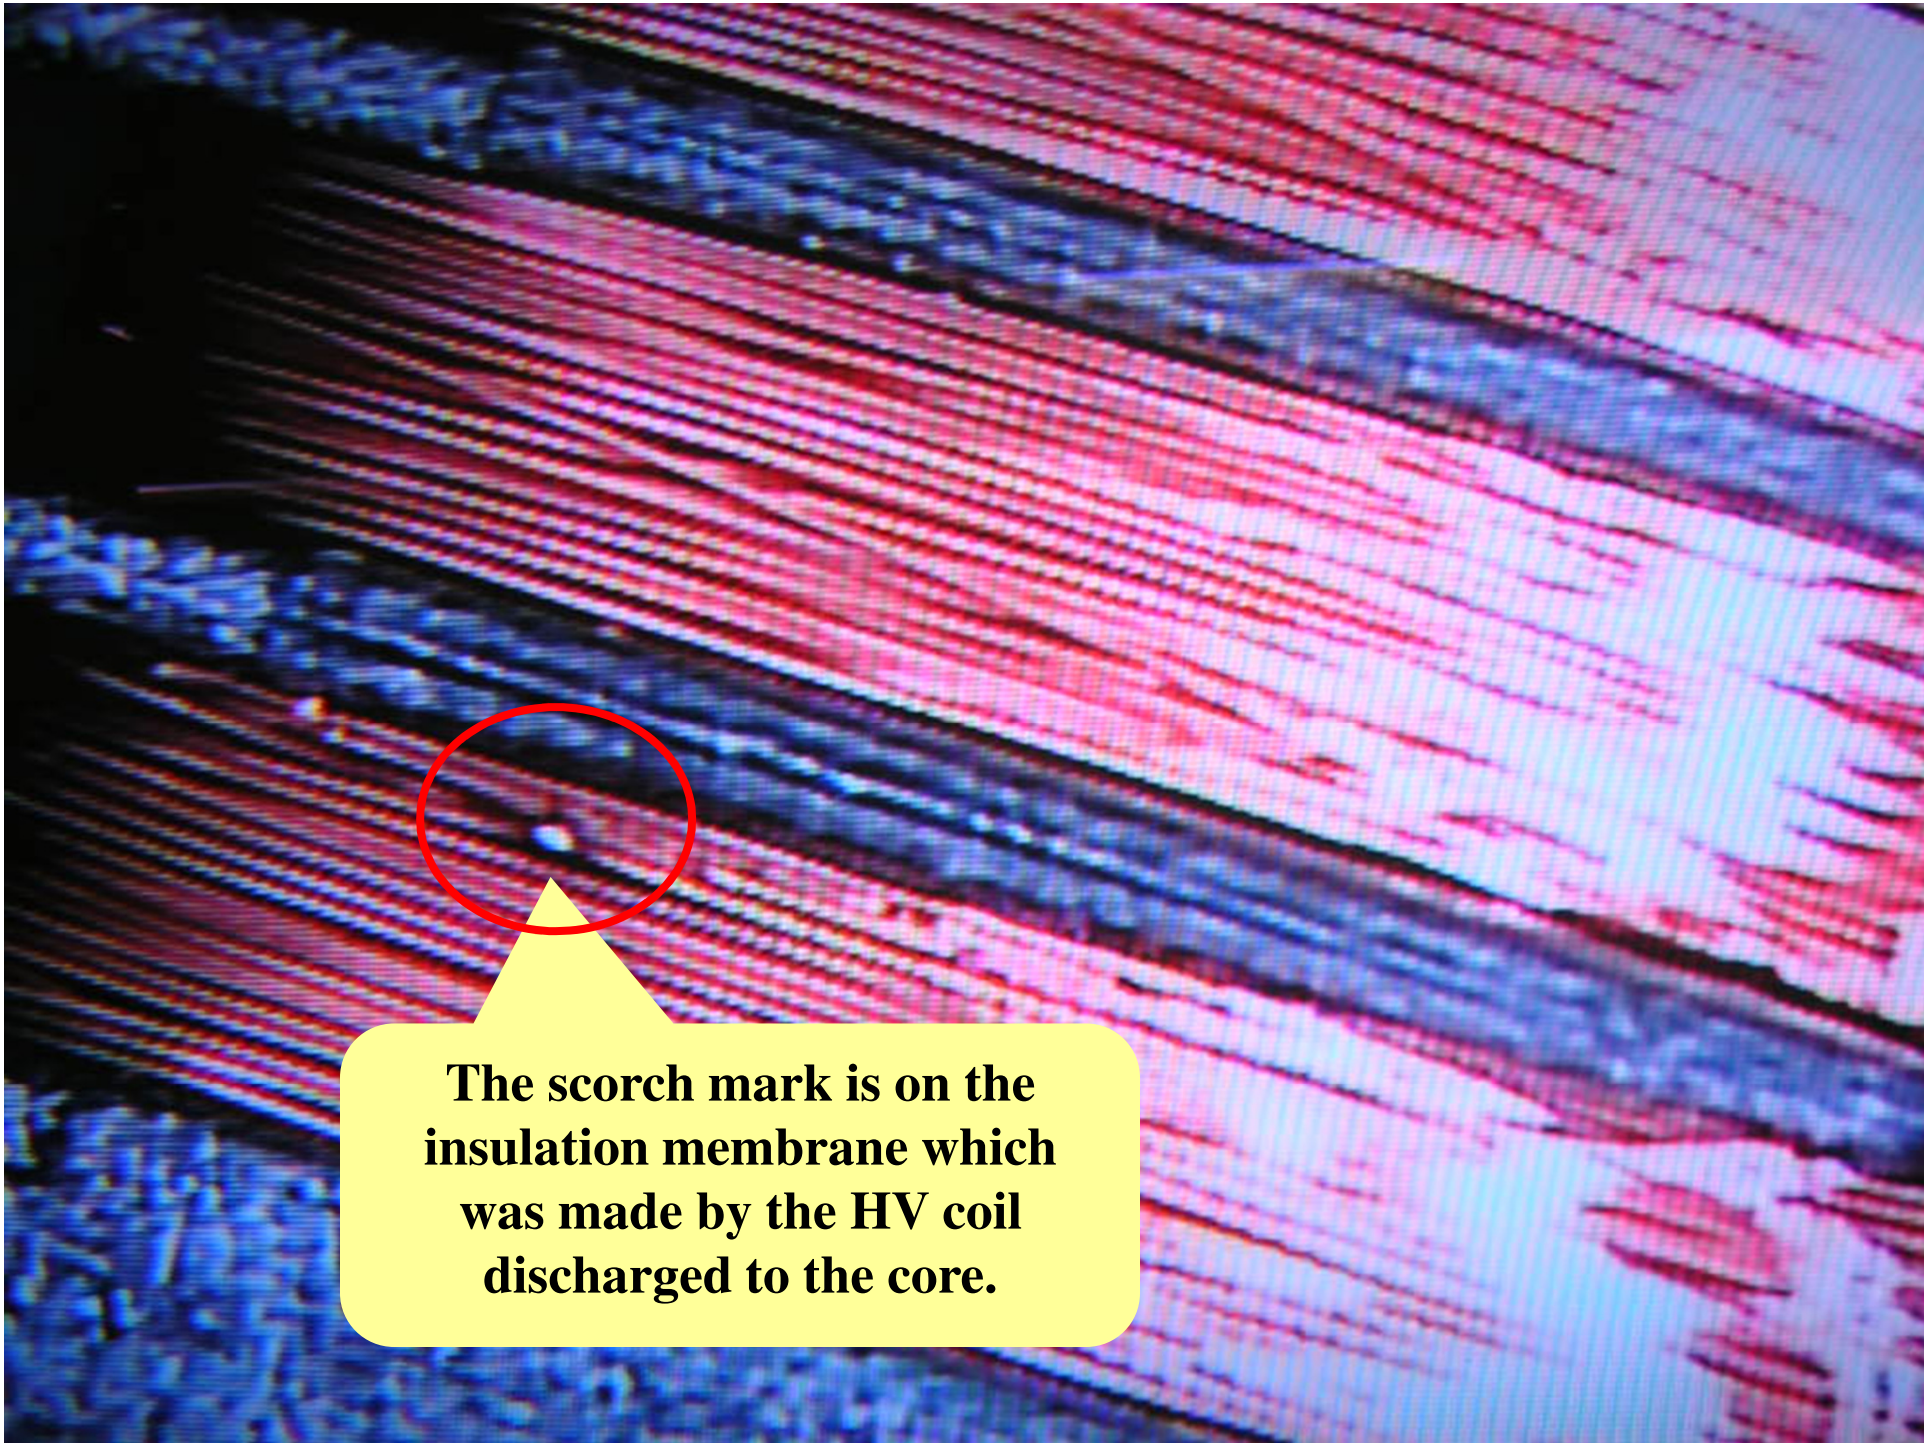
The scorch mark is on the insulation membrane which was made by the HV coil discharged to the core.

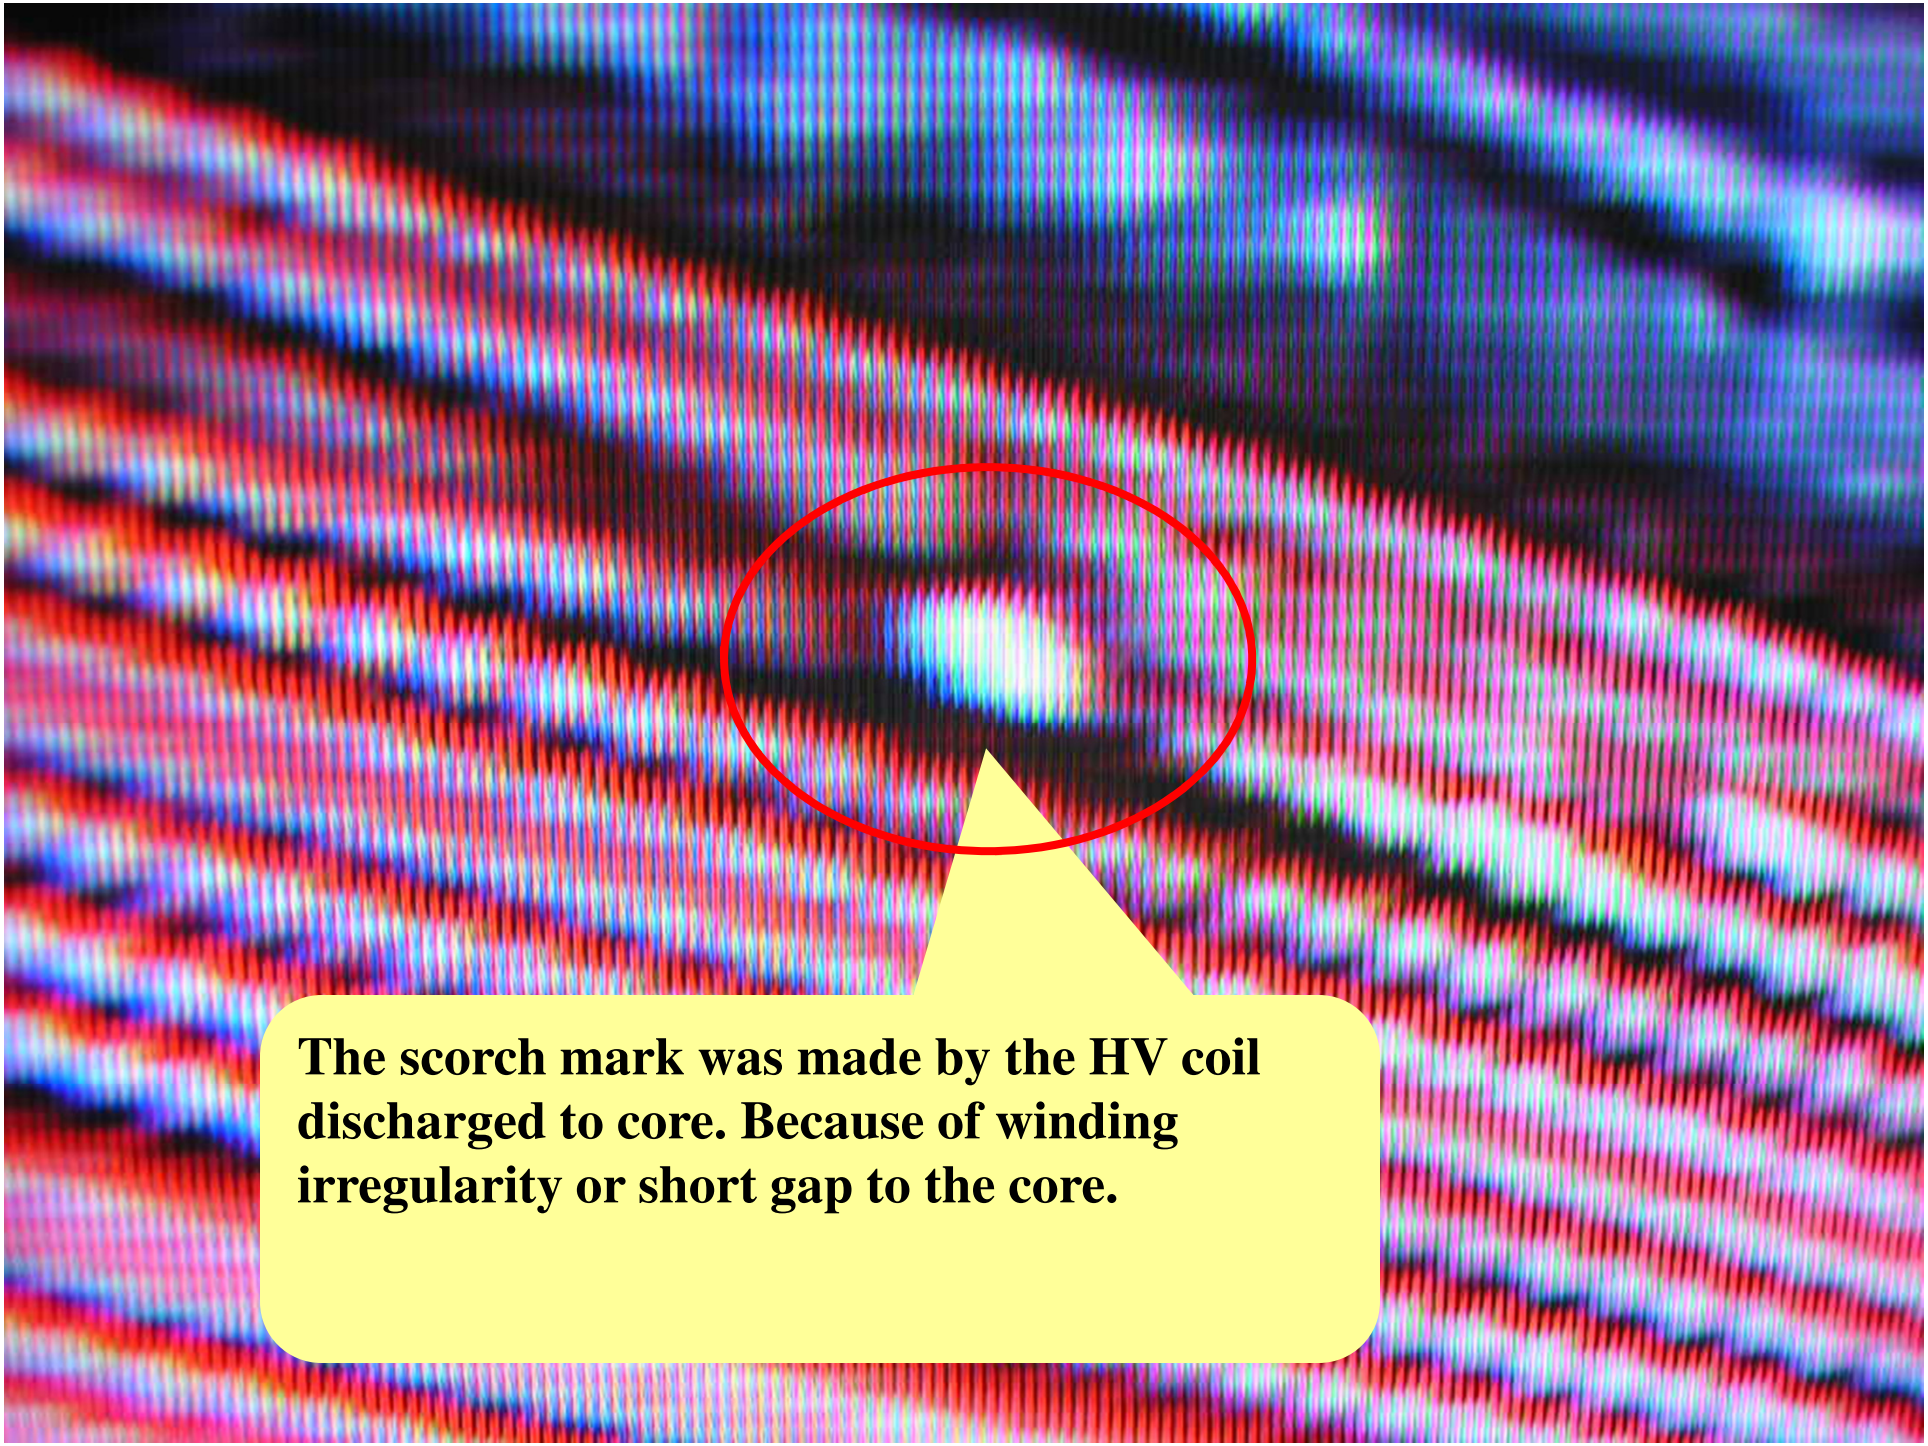
The scorch mark was made by the HV coil discharged to core. Because of winding irregularity or short gap to the core.

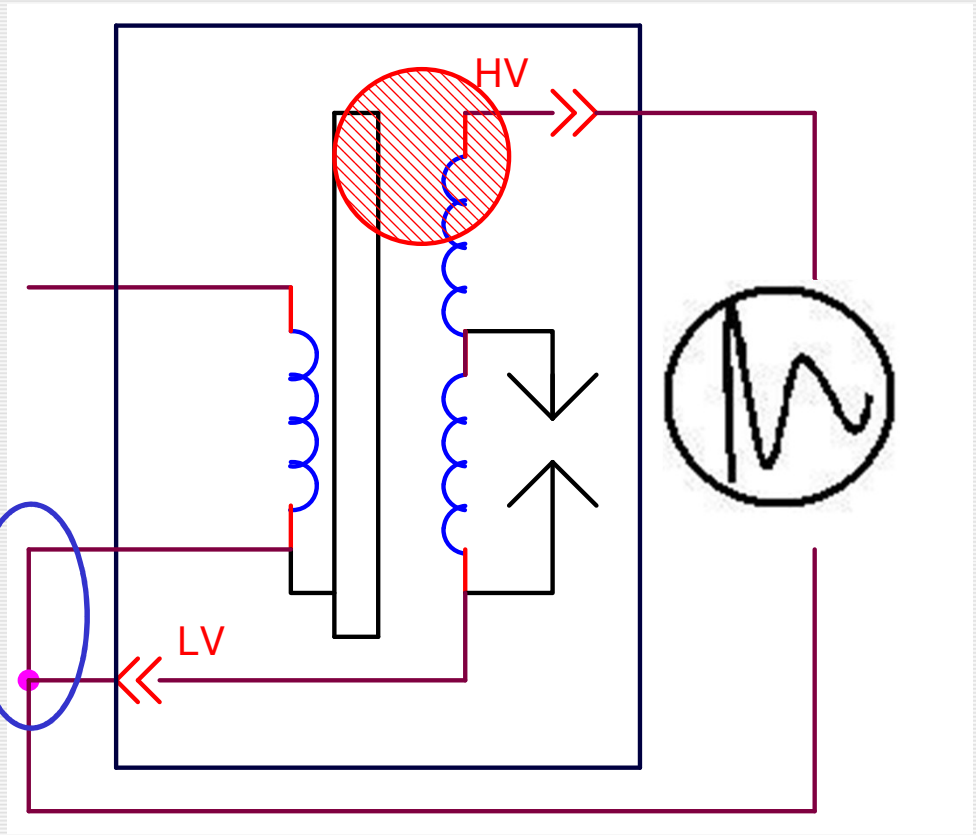
## LCD Inverter fransformer testing
## Impulse Winding Test (ITW-5000)

Connect to the LV if test only one side.
